PRITCHARDS POND DAM  
CT 00033

NAUGATUCK RIVER BASIN  
WATERBURY, CONNECTICUT

PHASE I INSPECTION REPORT  
NATIONAL DAM INSPECTION REPORT

Re: Pritchards Pond Dam  
Waterbury, Connecticut  
Contract #DACW-33-81-C0017

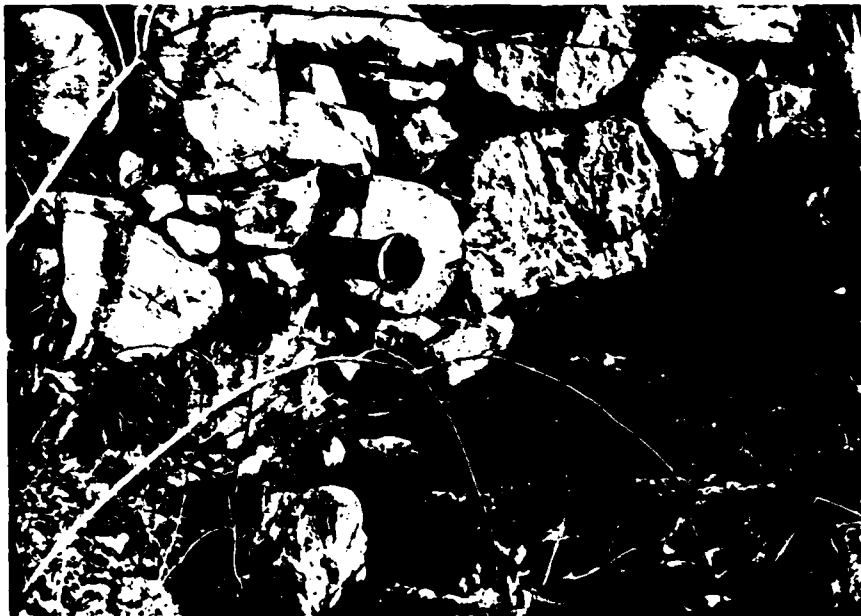
6. Spillway and outlet discharge pipes.
